# CONCRETE MICRO-HAMMERING SYSTEM

## WALLSTER

### Hammer drill bit compatible SDS-plus

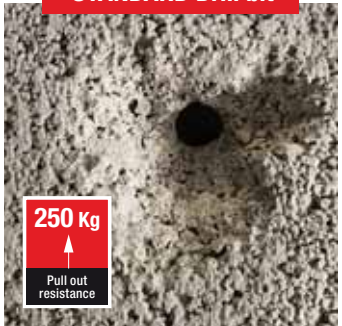
**STANDARD Drill bit**

**250 Kg**  
↑  
Pull out resistance

**Drilling**  
The wall is damaged, only 7mm thickness remains.

**Test of tearing for a chemical fixing**  
The fixation quickly gives in. Break in 250 kg.

Tests made with a SDS + machine GBH 2 with hammering in hollow concrete block with a chemical anchor.

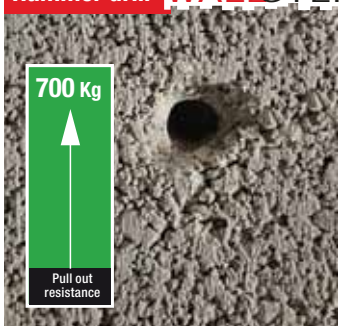
**Hammer drill WALLSTER**

**700 Kg**  
↑  
Pull out resistance

**Drilling**  
The wall is intact, and keeps its original thickness of 16mm.

**Test of tearing for a chemical fixing**  
The fixation resists perfectly. It is the wall which gives in. Break in 700 kg.
